Research Product 2001-01

Bradley Fighting Vehicle: Heat in the Driver's Compartment

January 2001

U.S. Army Research Institute for the Behavioral and Social Sciences

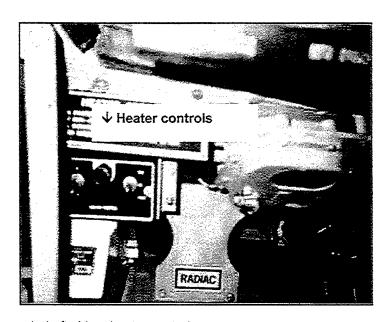
Figure 1. Left side – heater controls

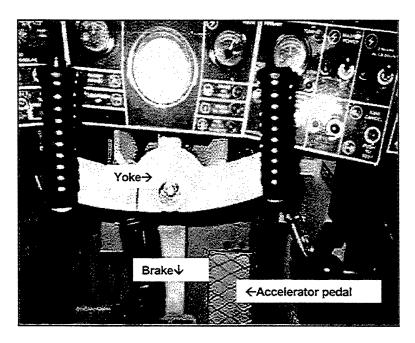
Figure 2. Center - steering yoke, foot pedals

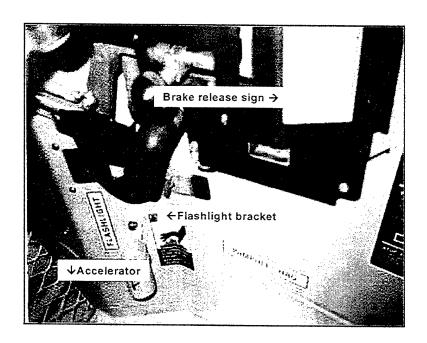
Figure 3. Right side (forward, low) – flashlight bracket

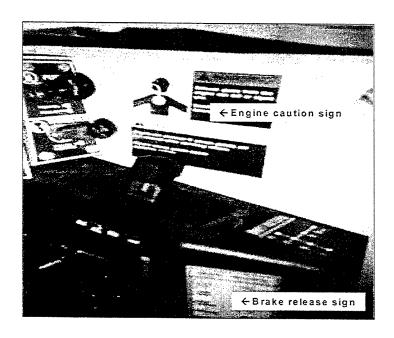
Figure 4. Right side (forward, high) – engine caution sign, brake release sign

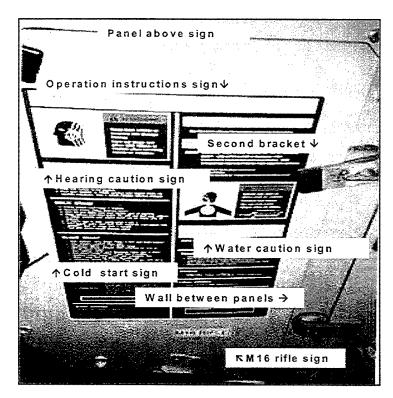
Figure 5. Right side (front) - forward engine access panel, with operation instruction sign

In other areas on the right side, however, the rise in temperature was very large, especially in areas adjacent to the engine access panels. Based on these initial and preliminary measurements, it was apparent that the M2A3's driver compartment was reaching a warm interior ambient temperature (100°F) and that some areas had surface temperatures in excess of 140°F. The next logical step was to compare these data to data collected from other vehicles.

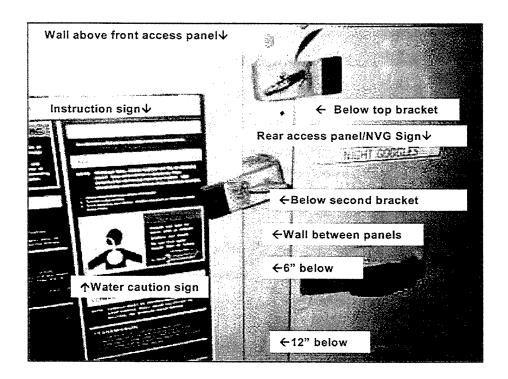
Figure 6. Right side (rear) - rear engine access panel, brackets, wall between access panels
